Edward Hobaica – Licensed Professional Home Inspector

Address: 123 Example Lane, Juneau, AK 99801
Prepared Exclusively for: Chris & Julie Frost
Inspection Date: December 31st, 2023

Type of Inspection: Pre-purchase

PROPERTY INSPECTION REPORT

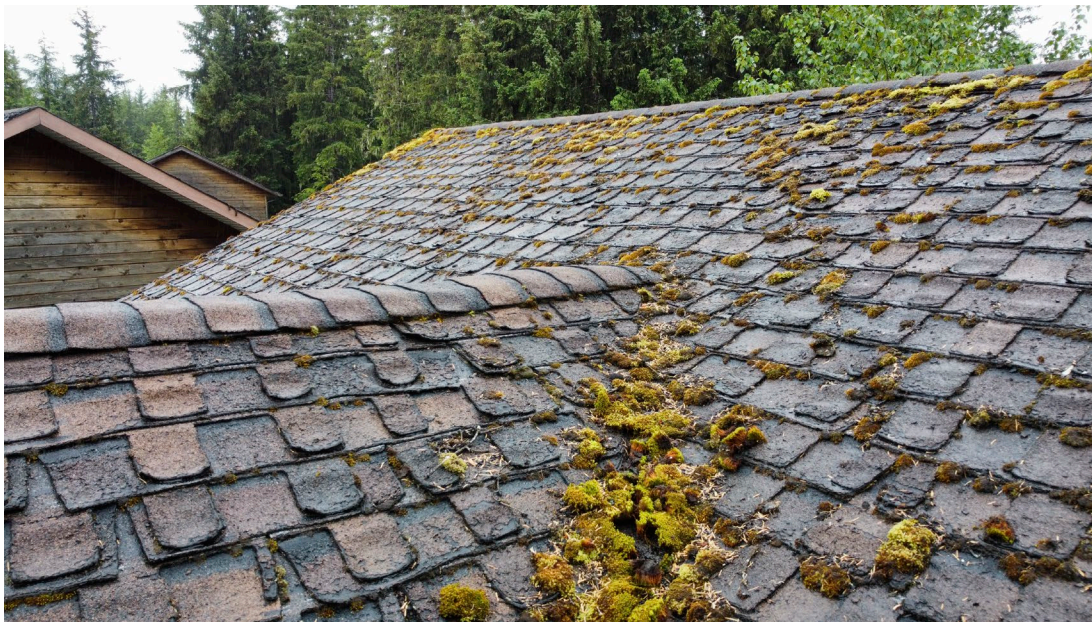
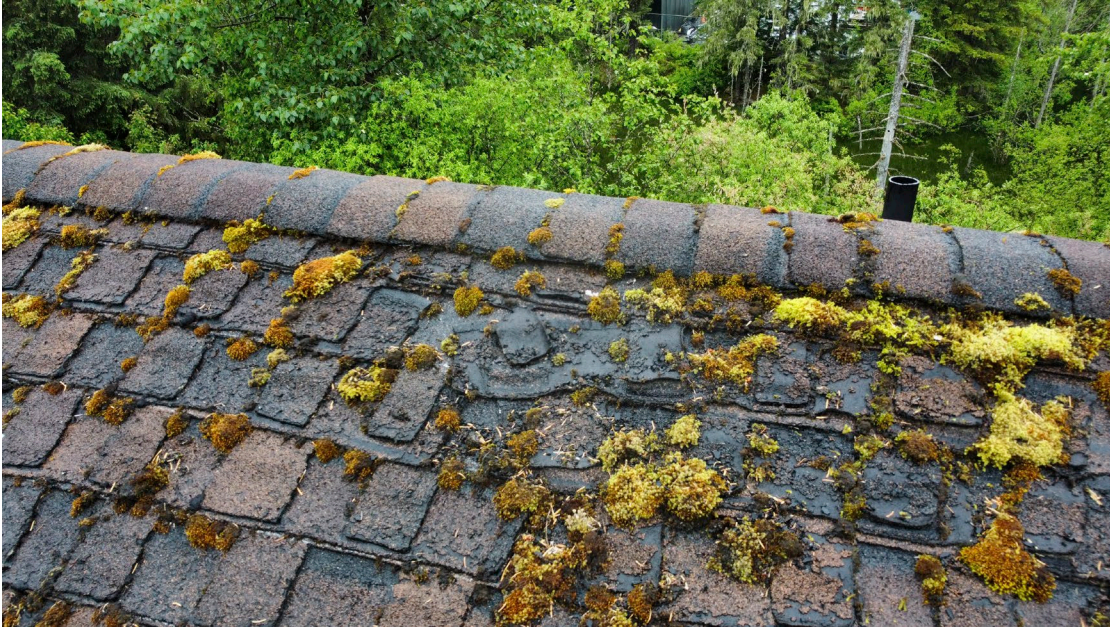
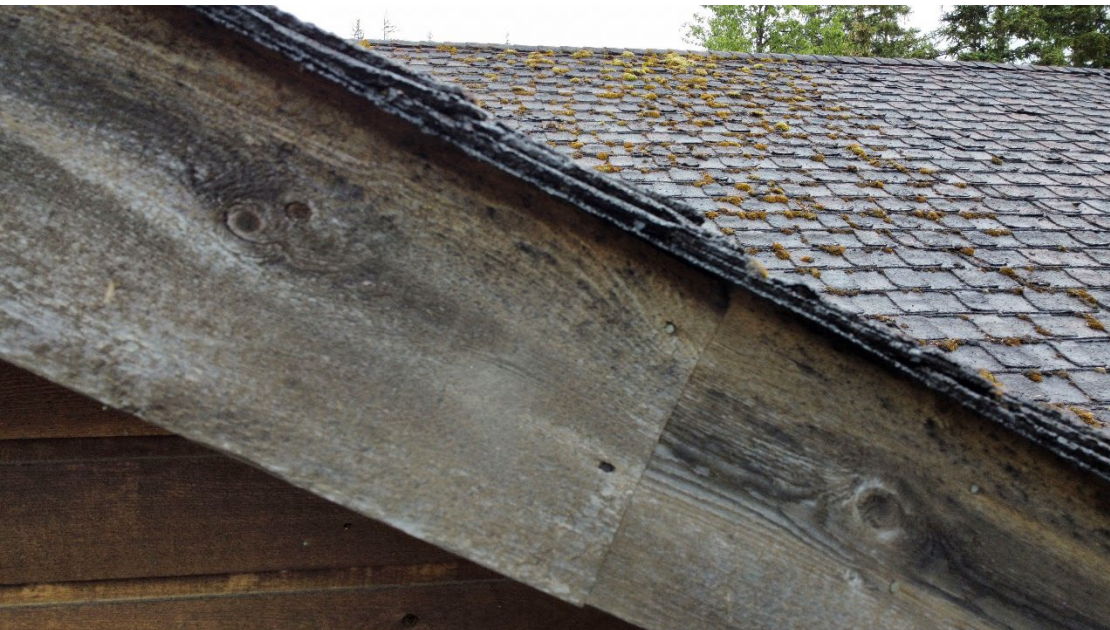
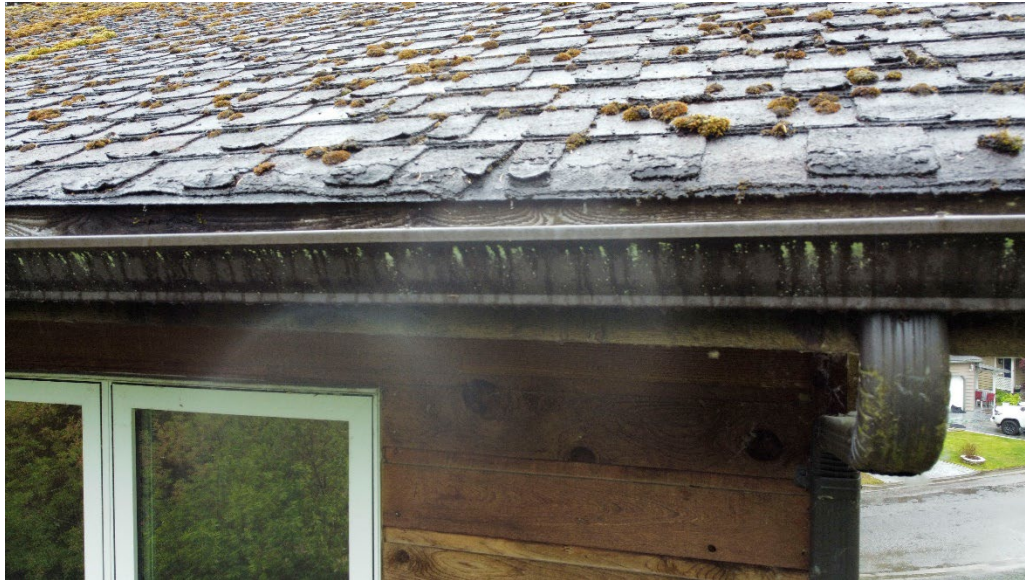
- **Missing shingles observed.**
- **NEWER CODE (2012): No drip edge flashing on the roof. Drip edge is now required for shingle roofs.**
- **Buildup observed in the gutters. The buildup hinders the proper flow of water and can cause damage to the roof covering material as well as the roof structure. Recommend clearing out the buildup in the gutters**
- **Growth buildup observed on the roof. Recommend cleaning off the growth to help preserve the service life of the roof covering material.**

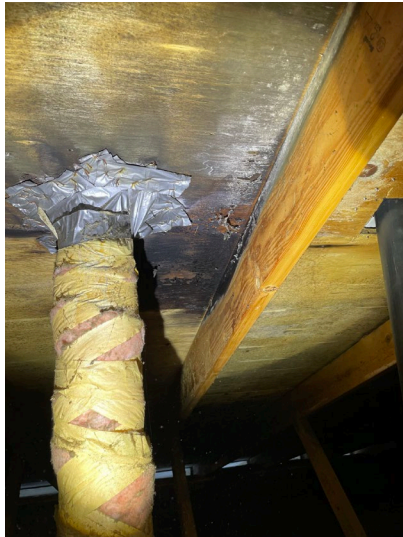
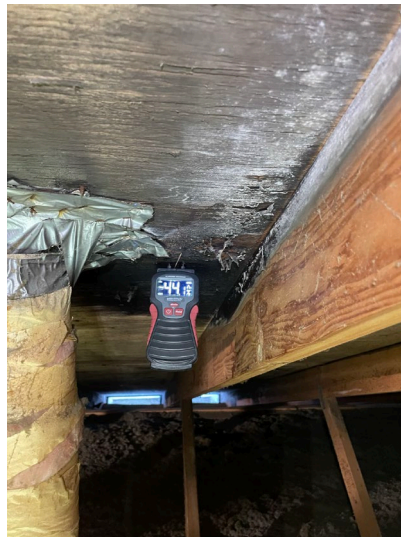
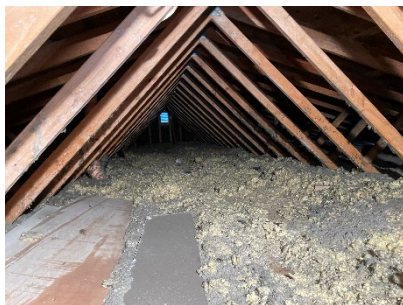
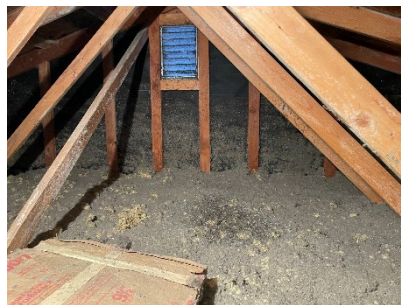
- Moisture intrusion observed in the attic. The area was probed with a moisture meter and provided readings of around 45%. Moisture contents of above 20% are conducive to rot and/or decay.
- No fireblocking wall installed in the attic. Due to the attic sharing a common space between two separate living spaces there needs to be a fireblocking wall. Section 302.11 of the 2018 IRC states the requirement for fireblocking.
- Moisture damage observed on the soffit/overhang.

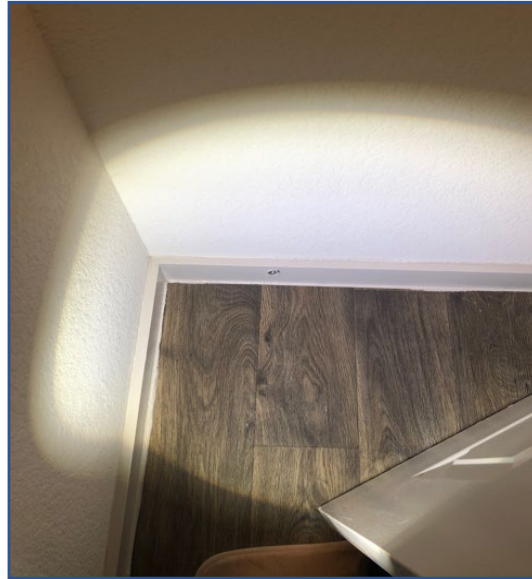
- **Missing door stop in the master bathroom's toilet room. Recommend replacement to prevent wall damage.**

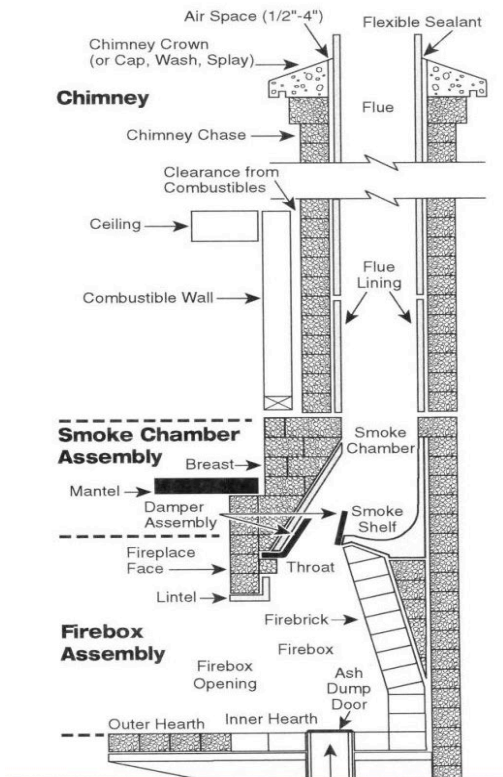
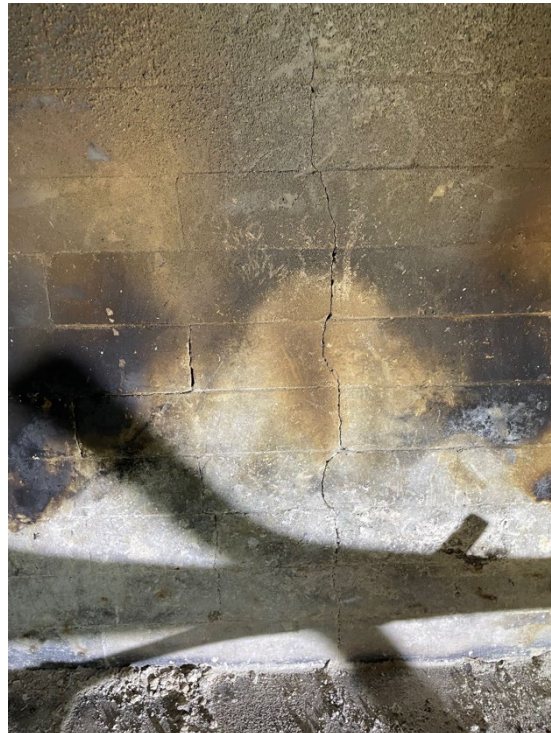
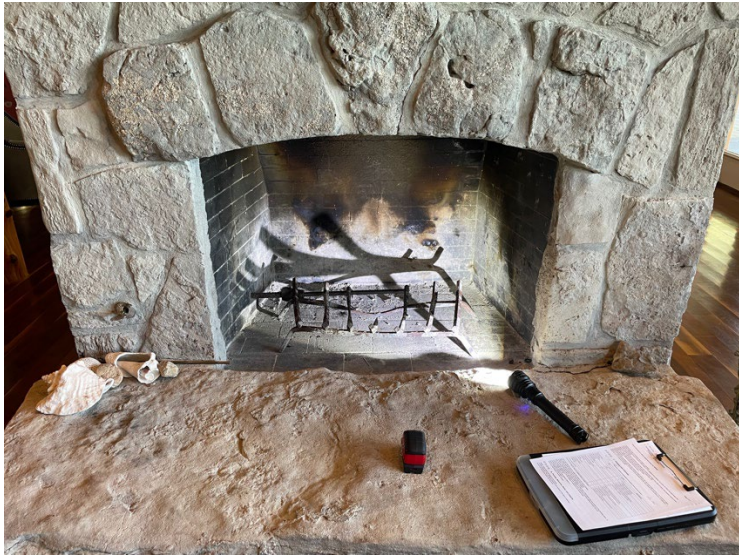
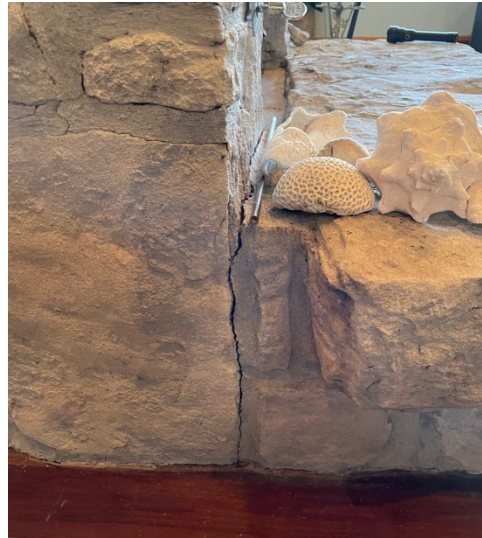
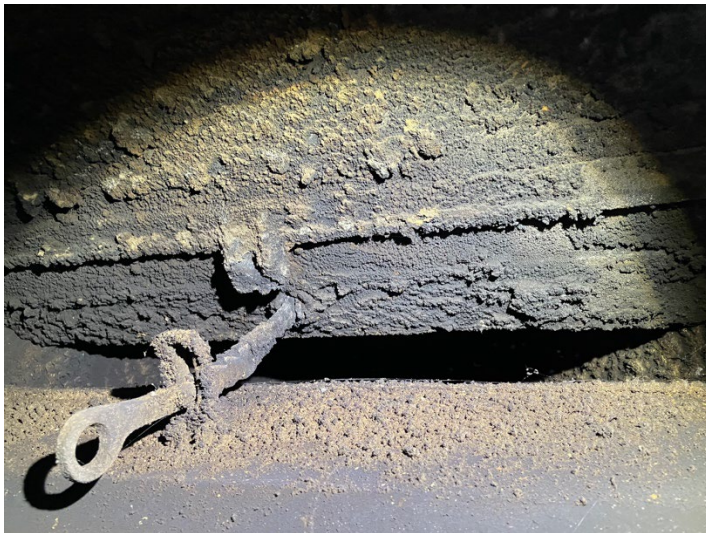
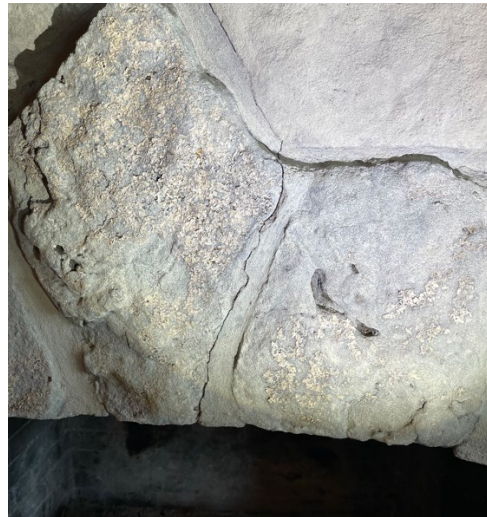
- **Crack in the firebrick. Recommend a fireplace expert evaluate further.**
- **Crack in the hearth extension.**
- **Substantial creosote buildup. This poses a fire hazard and recommend that the entire chimney be cleaned by a chimney cleaning expert.**
- **Small crack in the mortar above the fireplace opening.**

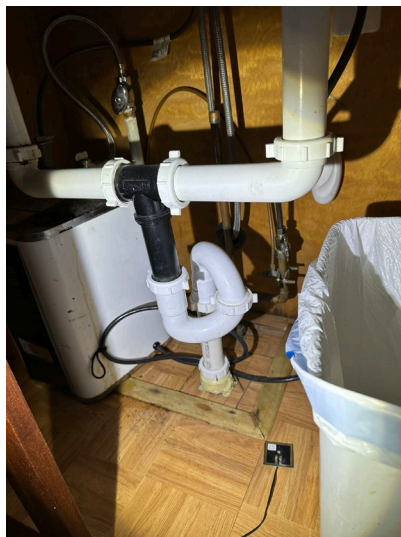
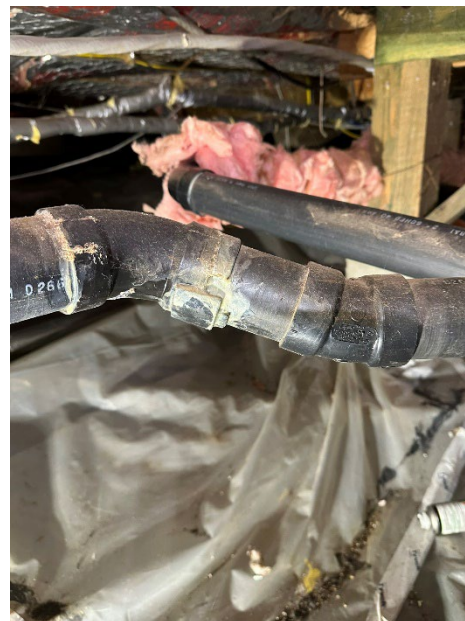
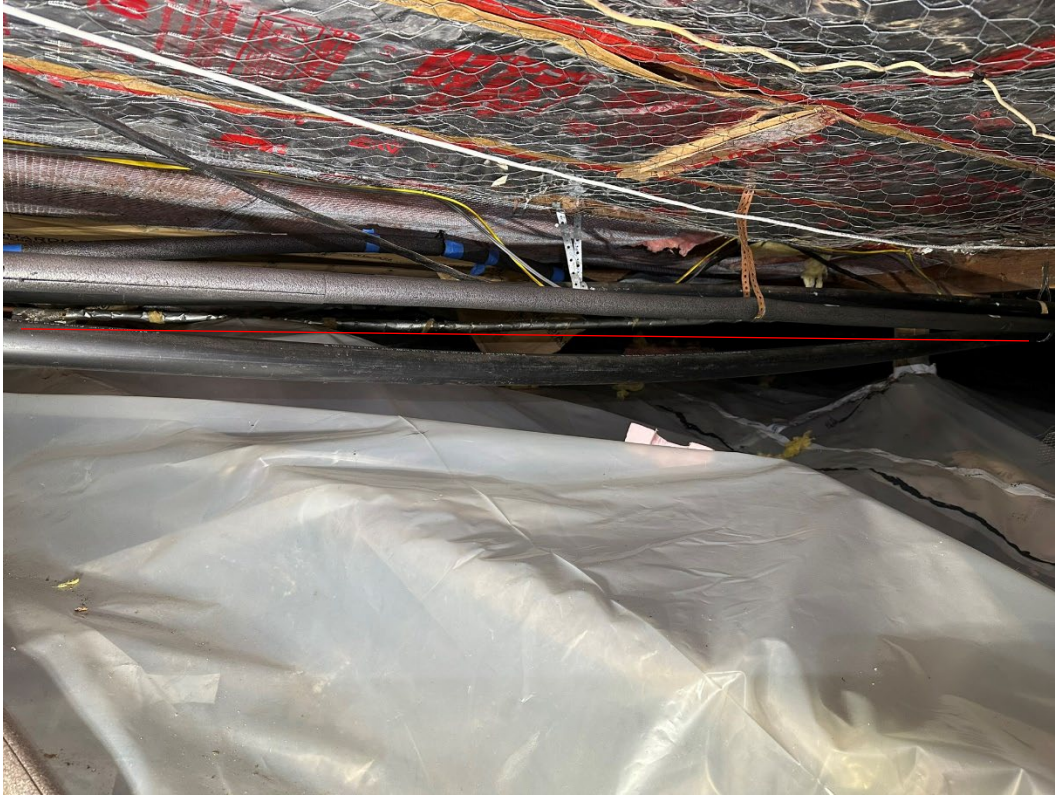
- S-Trap(s) observed on the plumbing system. S-Traps are not allowed as one major drawback of them is they could cause the system to lose its trap seal (the water well that prevents hazardous gases from traversing through the drain piping into the property).
- Multiple drain piping observed to have a negative/level slope. IRC requires that gravity drain piping have positive slope (the amount of slope depends on the diameter of the pipe). The level/negative sloping can cause backups in the drainage system.
- Lack of or inadequate piping support observed. The lack of support can put extra pressure and strain on the joints and the piping making it more likely for a piping failure. Recommend a licensed plumber investigate further and install proper support.
- Damaged joint on the drain line observed.
- Hallway bathroom's shower/tub drain stopper did not appear to function properly.

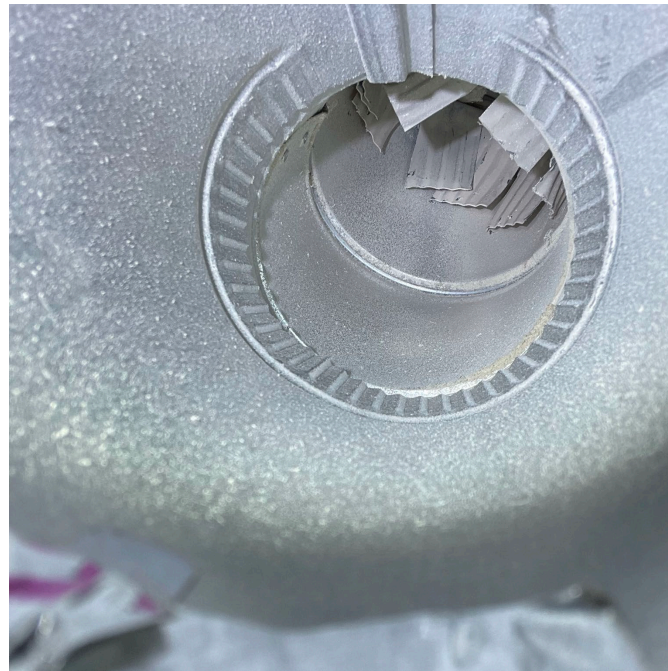
• Duct interior is not smooth. This can easily cause a blockage in the piping and become a fire hazard. [IRC M1502.4]
