**Edward Hobaica – Licensed Professional Home Inspector**

**Address:** 123 Example Lane, Juneau, AK, 99801

**Inspection Date:** May 1<sup>st</sup>, 2022

**Type of Inspection:** Pre-purchase Inspection

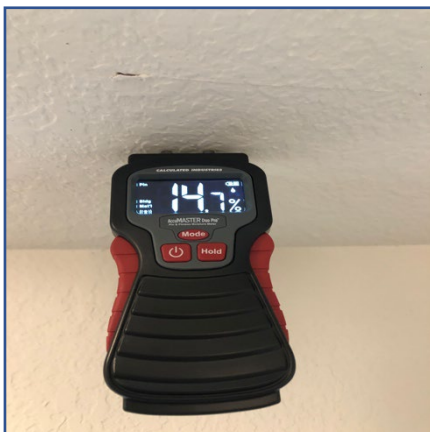
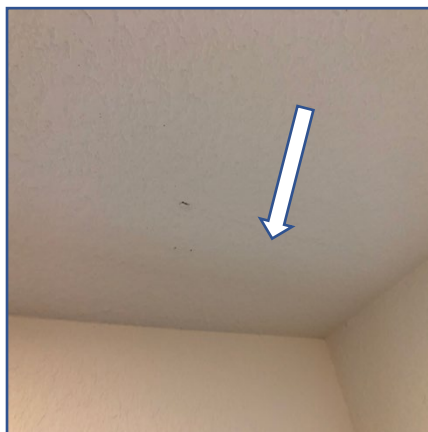
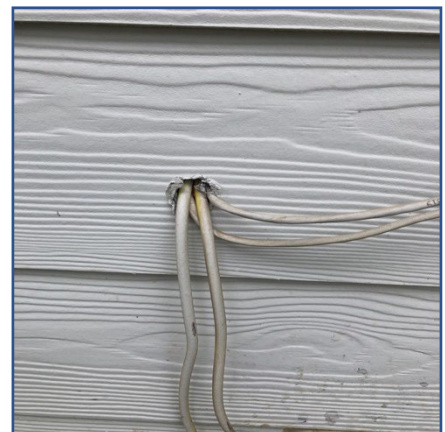
- Crack in the ceiling above the shower. Moisture meter does not indicate high moisture levels. Recommend repair the crack.
- Electrical box against house is not weathertight. The perimeter of the box should be caulked.
- The penetration depicted in the photo should be caulked. The penetration is next to the main service panel.
- Gap between master bath shower tile and window. This will allow water an access point into the walls possibly causing future water damage. Recommend grouting and sealing up gaps such that it becomes water tight.
- Gap between garage trip and exterior siding. Recommend resealing spot.

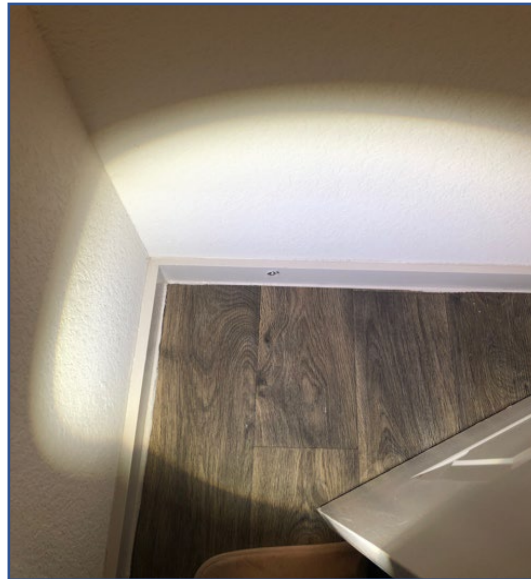
- a. **Missing door stop in the master bathroom's toilet room. Recommend replacement to prevent wall damage.**

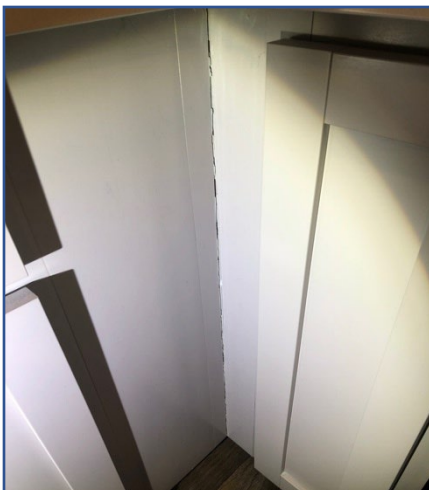
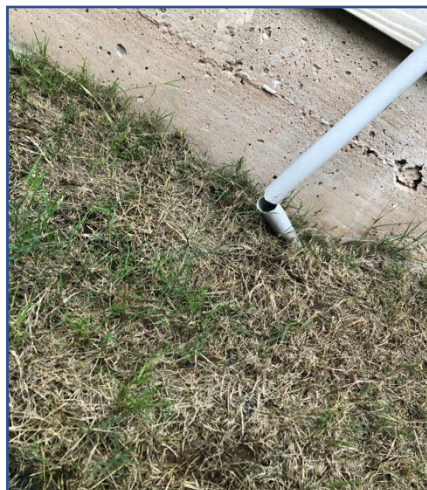
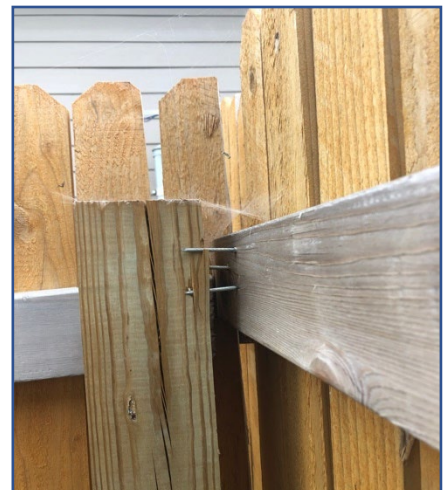
- a. Exterior cable conduit is broken. Recommend replacement.
- b. Crack in the corner of the kitchen cabinetry.
- c. North side of fence is not properly attached to fence post.

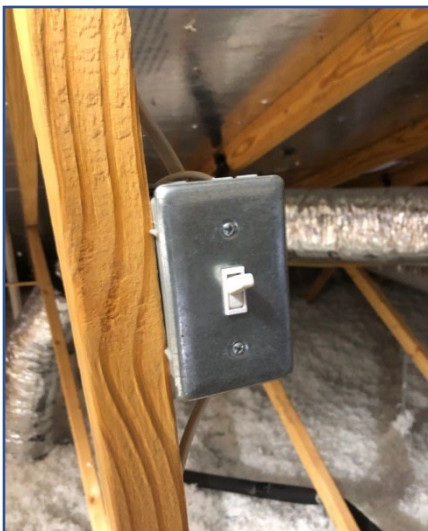
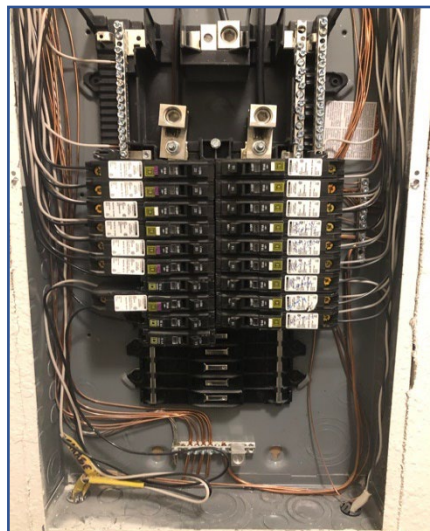
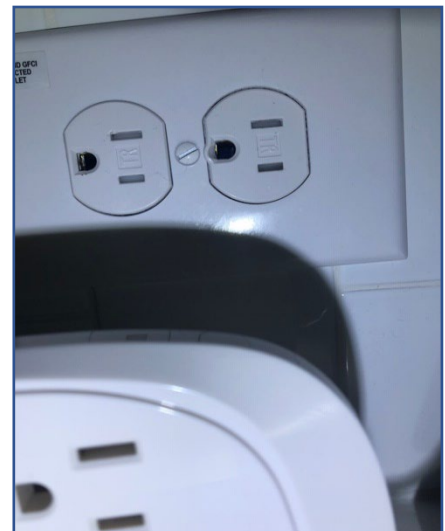
8. Door bell function acceptable: ☐ Yes ☐ No ☐ Not present ☒ Smart camera (not tested)
9. Comments:
  - a. Electrical outlet to the right of the stove appears to have partially melted at the ground socket. Recommend further investigation by a licensed electrician and replacement of the outlet.

- b. Switches and outlets in the attic have a metal face plate. These appear to not be bonded. Recommend further investigation by a licensed electrician.

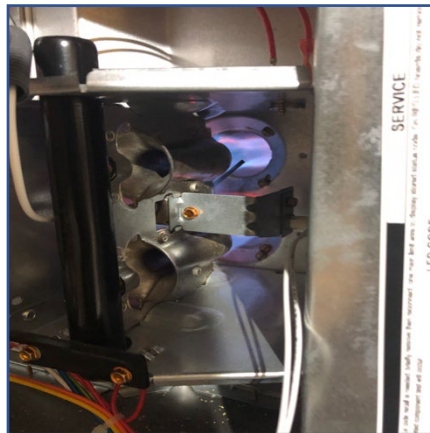
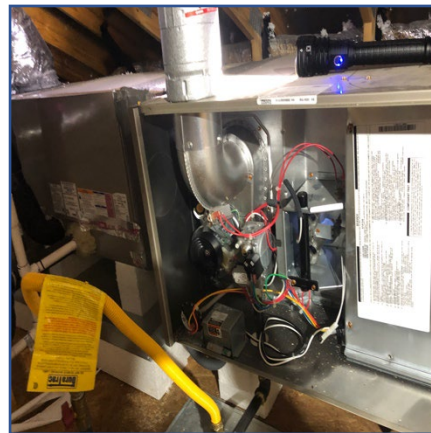
- a. **LOW DELTA T:** The temperature differential (15 degrees) across the air conditioning coil was below the widely accepted range (15-21 degrees). This could be due to several factors including age, incorrect blower speed, static pressure, or low refrigerant. A low temperature differential (Delta T) is only used as an indicator of the need for further evaluation. Servicing of unit and charging of refrigerant may result in increased temperature differential and efficiency. While servicing, technician should monitor charged pressure over time to determine if a leak is present.

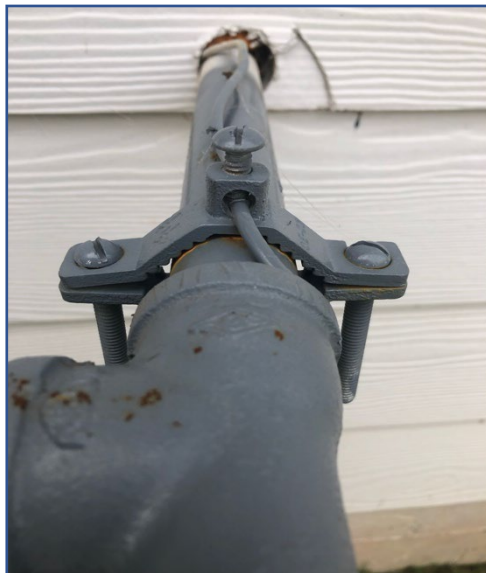
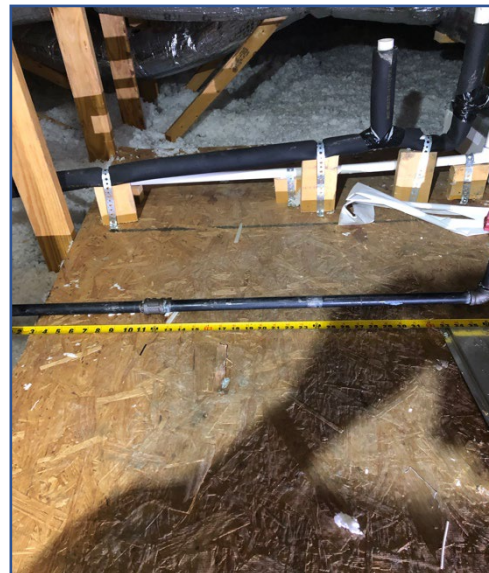
a. Paint on the grounding/bonding wire. Paint can inhibit/prevent the flow of electricity. Recommend removing the paint from the wire and the screw.

b. Since the gas pipe is on the maintenance platform recommend securing the gas pipe and installing protection to prevent accidental contact causing damage to the gas pipe.

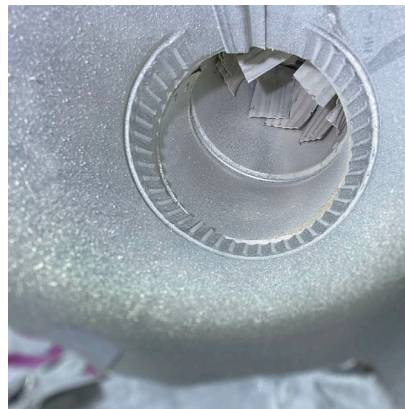
a. Duct interior is not smooth. This can easily cause a blockage in the piping and become a fire hazard.  
[IRC M1502.4]
